PHOTOGRAPHIC SURVEY

PROJECT: Corrosion Engineering Evaluation of a Buried Welded Steel Water Storage Reservoir

STRUCTURE: Interior and Exterior of a 7,500 Gallon Welded Steel Water Storage Reservoir

OWNER: Wheeler Crest Community Service District

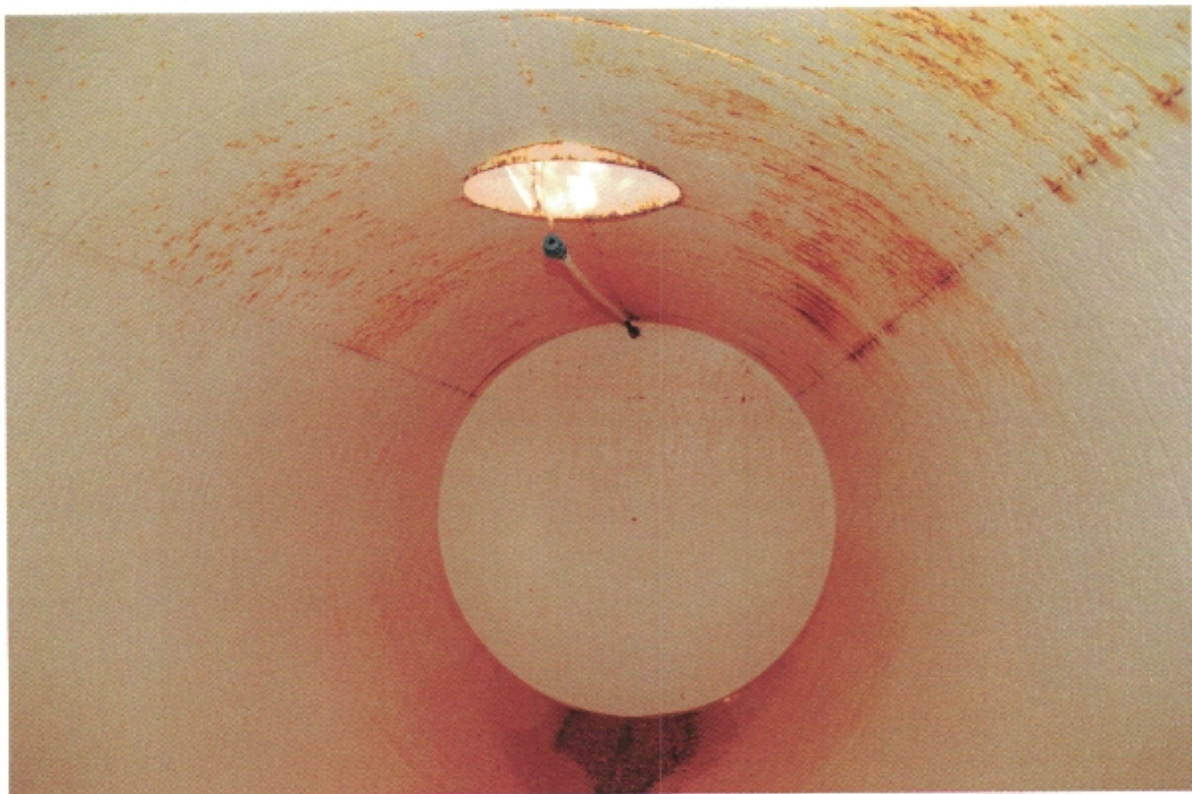
I-1 View of the interior surfaces of the reservoir, illustrating previous pitting on all surfaces and moderate to severe corrosion on the upper surfaces.

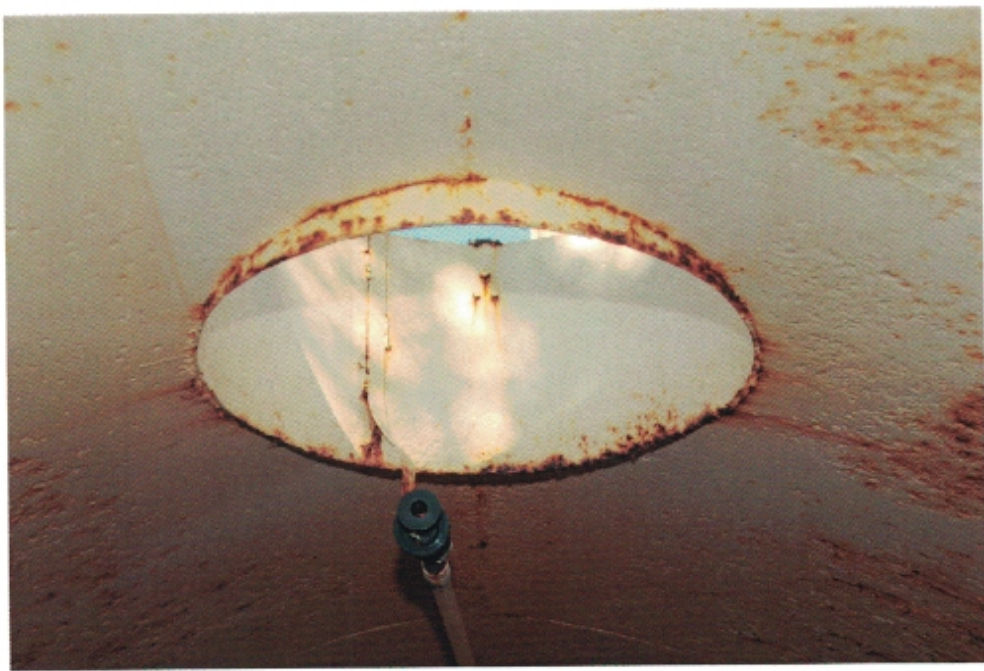
- I-2 View of the manway, illustrating moderate to severe corrosion at the lower circumference of the hatch curb.

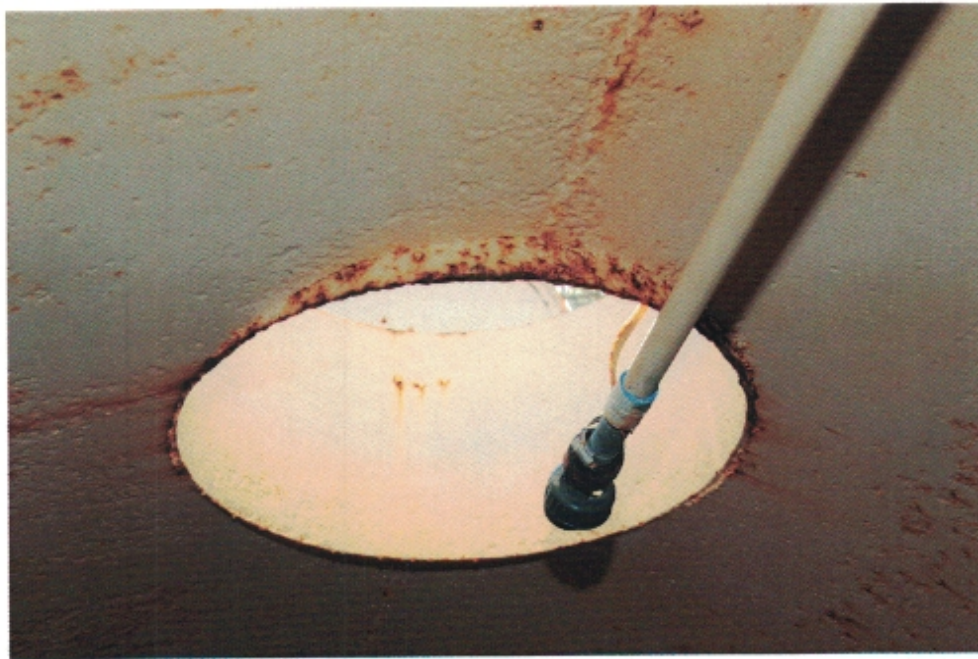
- I-3 Same as Photo I-2, except from a different angle.

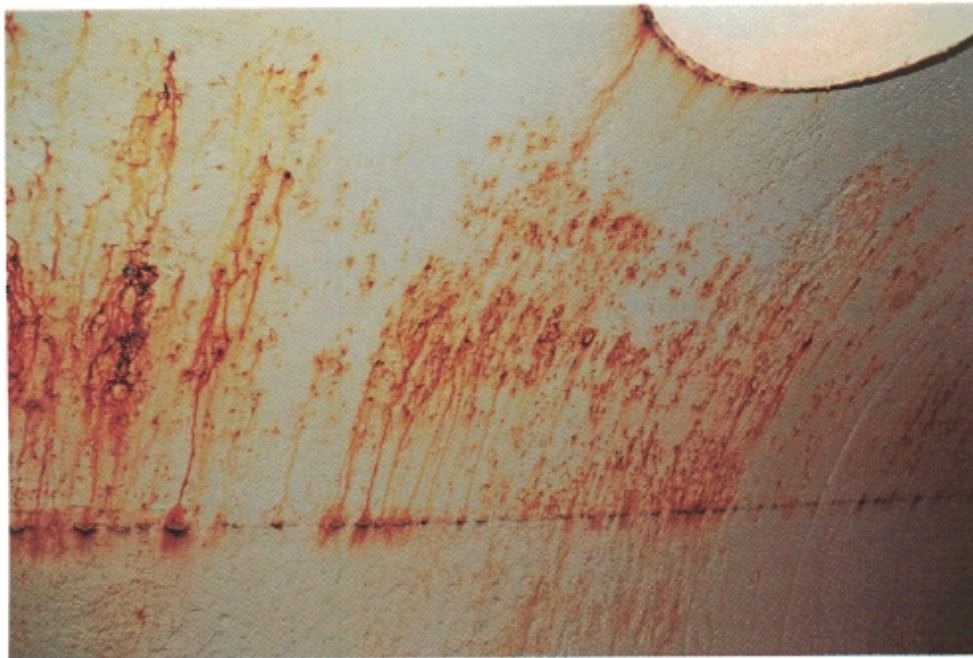
- I-4 Close-up view of the shell just above the high waterline, illustrating moderate to severe corrosion at and above the waterline.

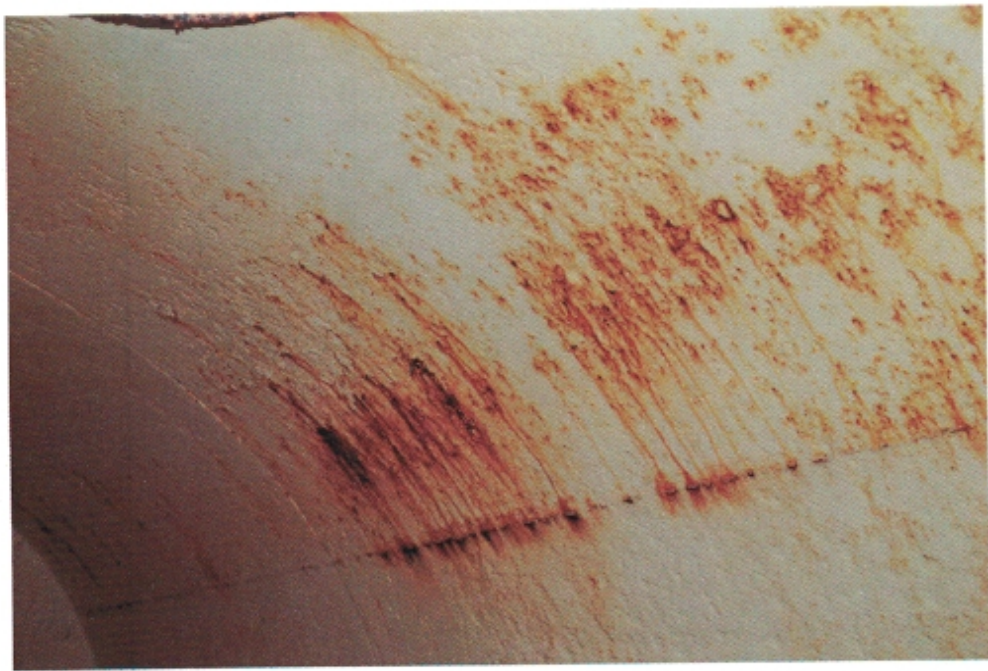
I-5 Same as Photo I-4, except in a different location.

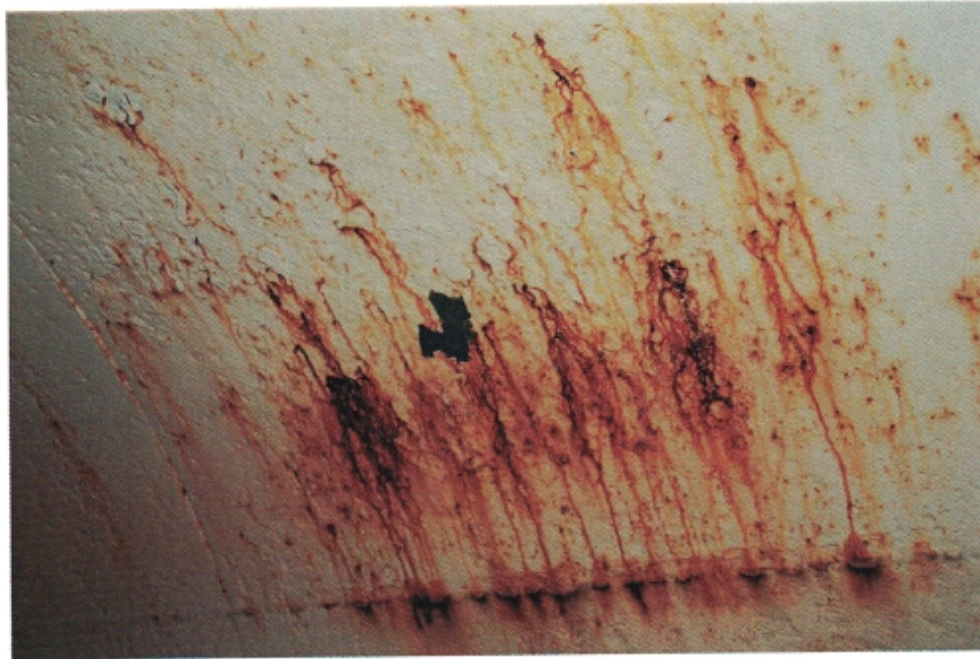
I-6 Same as Photos I-4 and I-5, except in a different location. Note area where the coating is starting to delaminate from the substrate.

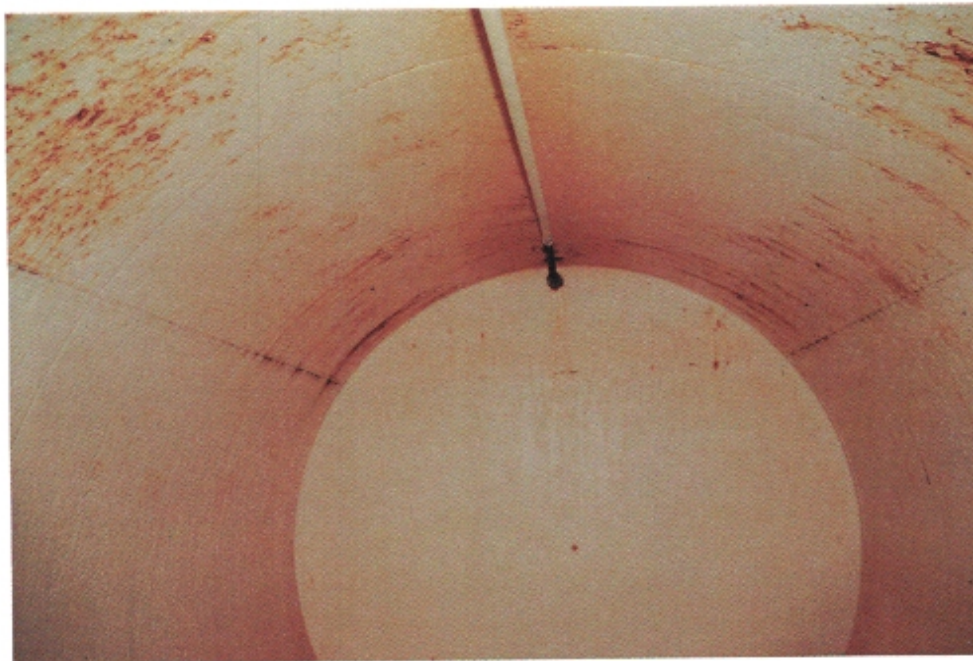
I-7 View of a portion of the reservoir, illustrating previous pitting on all surfaces and moderate corrosion on the upper portion of the reservoir.

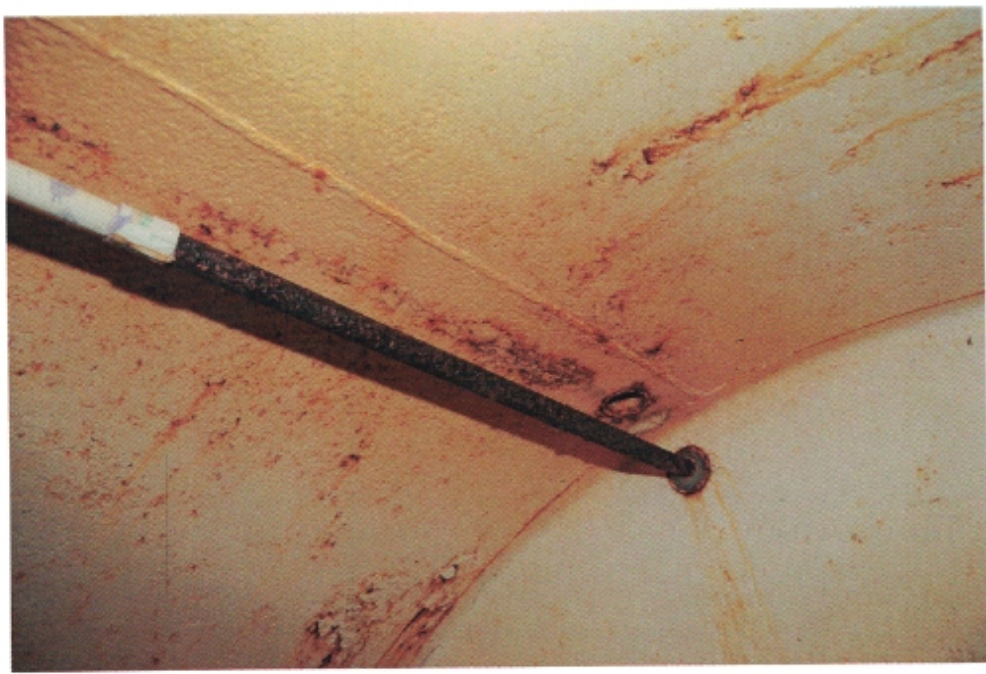
I-8 View of the inlet pipe where it enters the reservoir, illustrating severe corrosion of the carbon steel portion of the pipe.

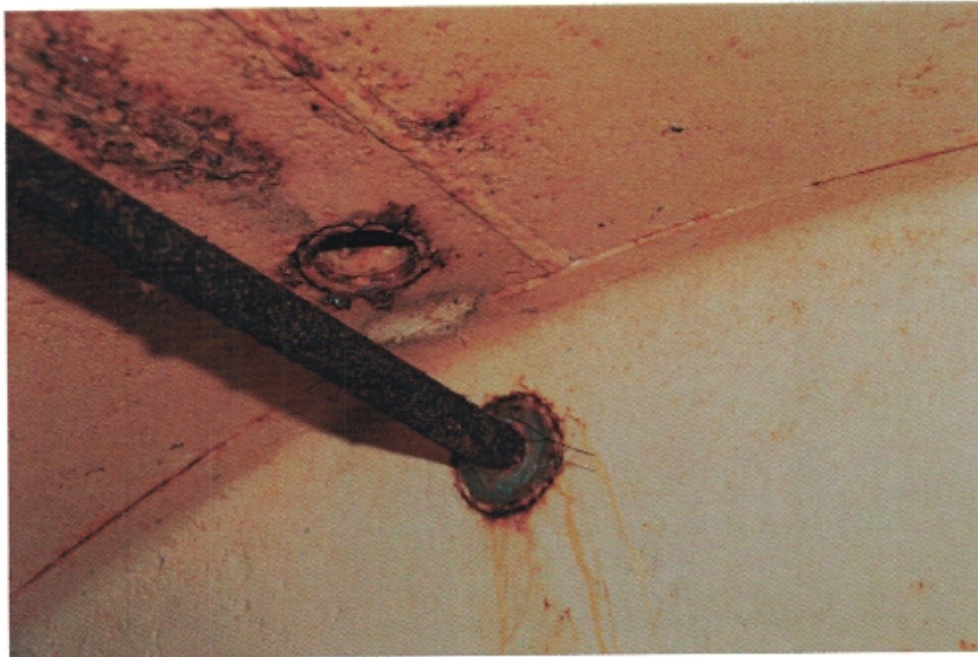
I-9 Same as Photo I-8, except a closer view of the carbon steel portion of the pipe.

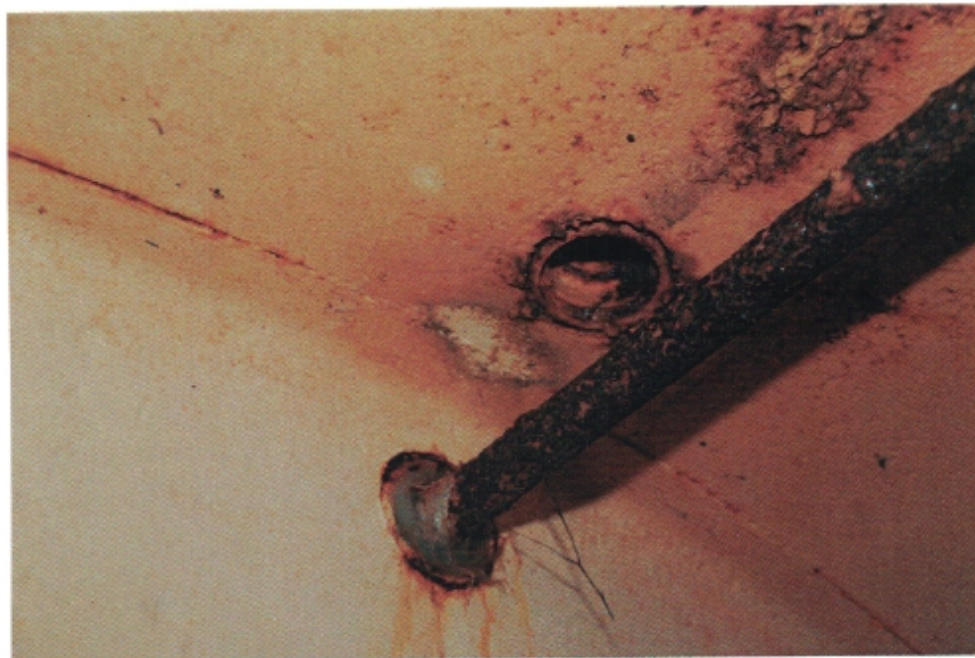
I-10 Same as Photo I-9, except from a different angle.

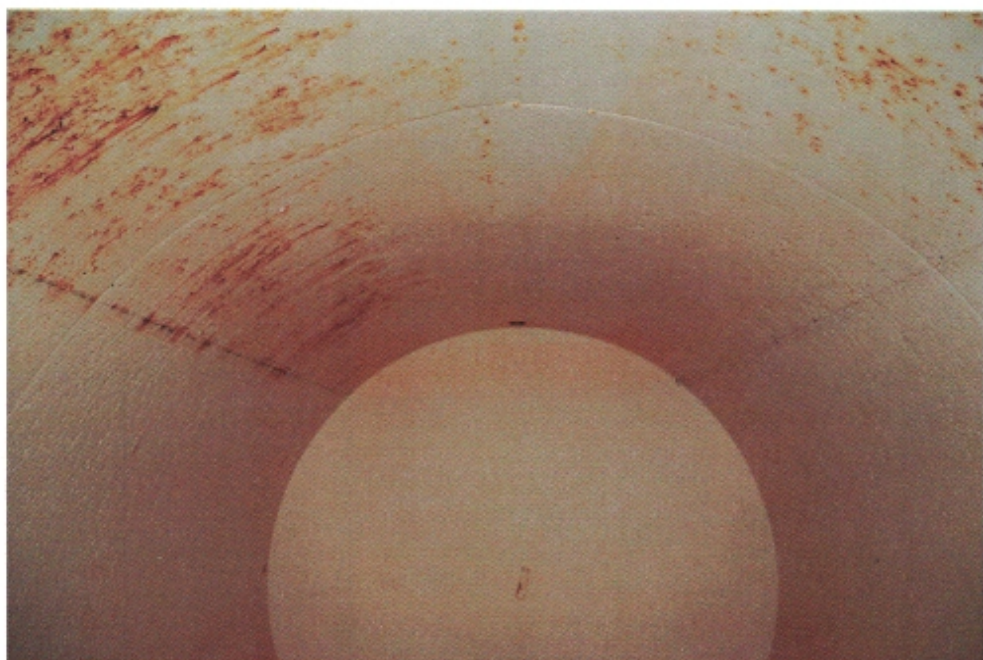
I-11 View of the opposite end of the reservoir, illustrating previous pitting on all surfaces and moderate corrosion on the upper portion of the reservoir.

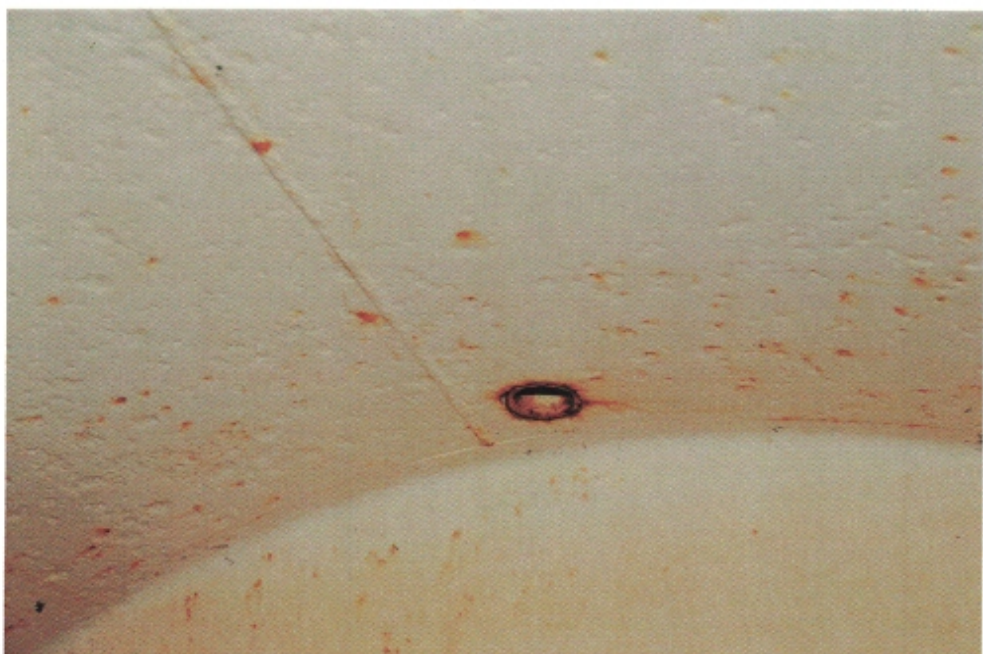
I-12 View of the upper portion of the reservoir, illustrating moderate corrosion at the circumference of a capped penetration and minor corrosion on the adjacent surfaces.

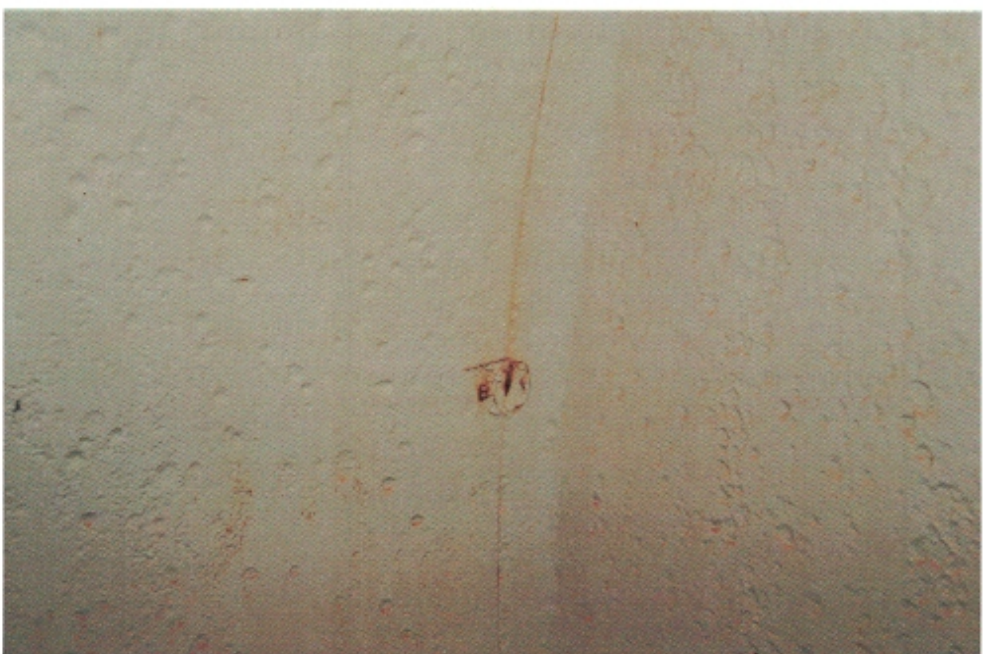
I-13 View of the shell where it meets the dished head, illustrating a defect at the weld and minor corrosion on the adjacent surfaces.
